TEST REPORT

REPORT NUMBER: 67115-120160
DATE OUT: December 22, 2015

Sample Information			
Product Description:	Two (2) Carabiner Two (2) straps/harness system (62407) Two (2) carabiner with straps with metal buckle (62408)		
Item/ Style Number:	N/L		
Purchase Order Number:	-----	No. of Sample Submitted:	6
Country of Origin:	NA	Country of Destination:	NA
Vendor/ Agent:	-----	Manufacturer:	-----

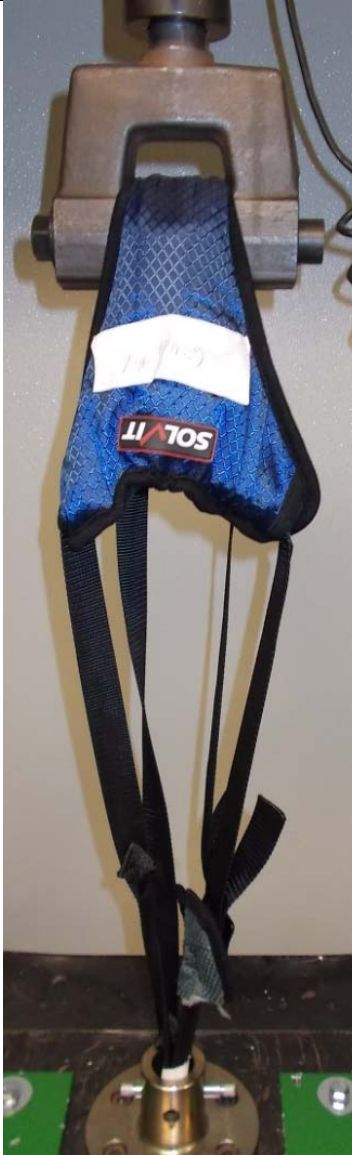
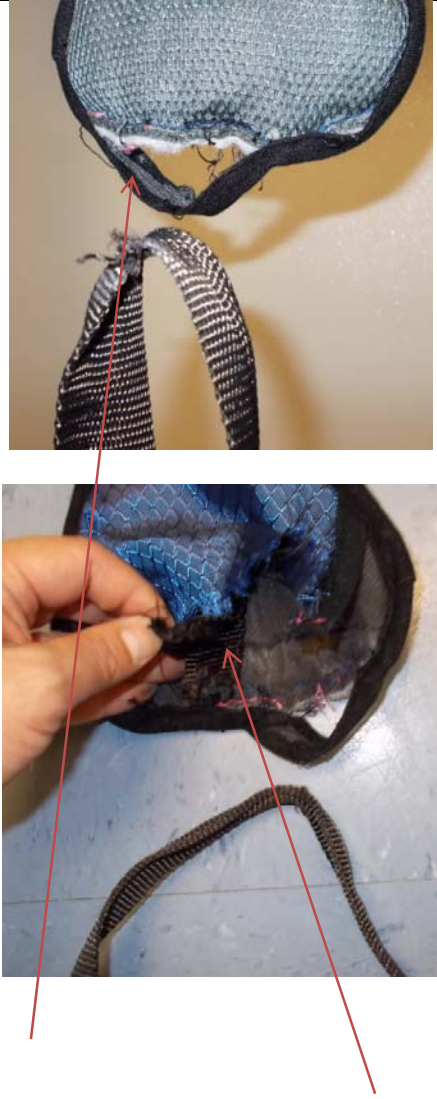
Straps/Harness system (62407) (#1)

Set up	Final failure (inner strap in the main section – breakage/tear and noticeable deformation of metal buckle)

<p>Noted @ 3,930 lbs.</p>

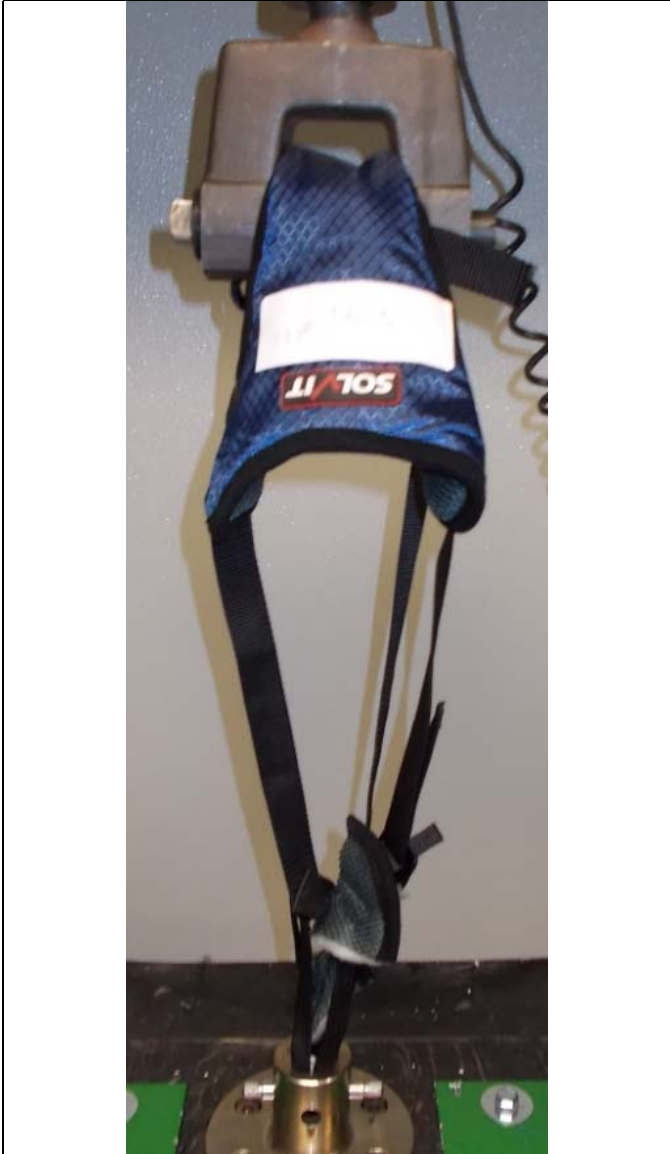
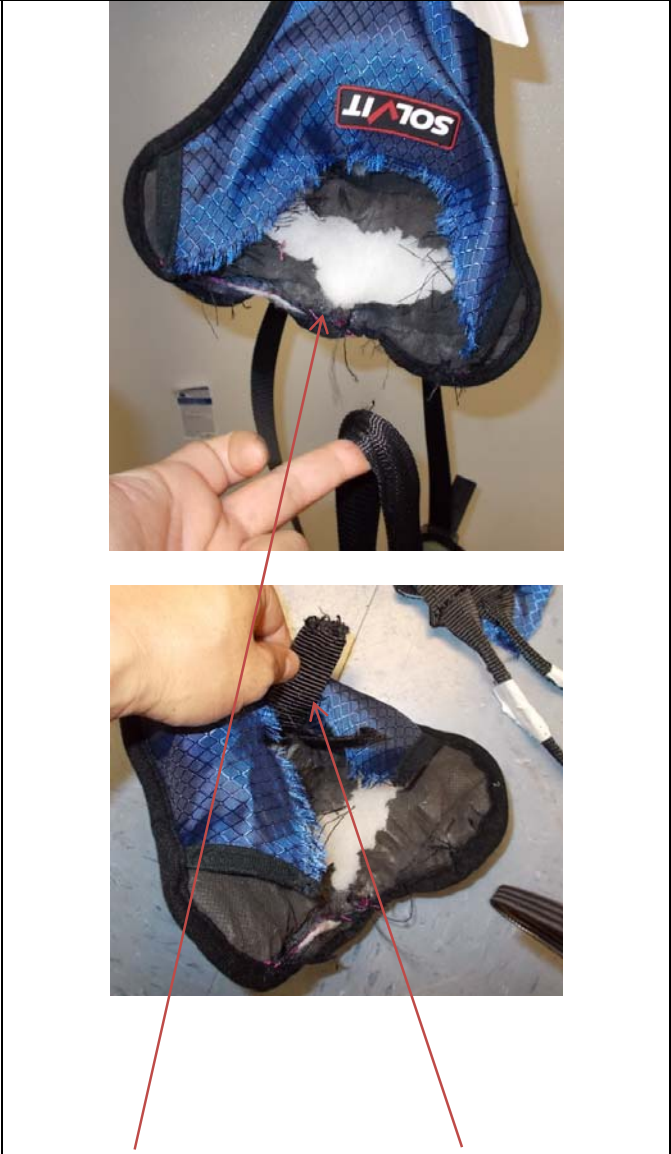
Straps/Harness system (62407) (#2)

Set up	Final failure (inner strap in the main section – breakage/tear and noticeable deformation of metal buckle)
--------	---------------------------------------------------------------------------------------------------------------

Noted @ 4,070 lbs.

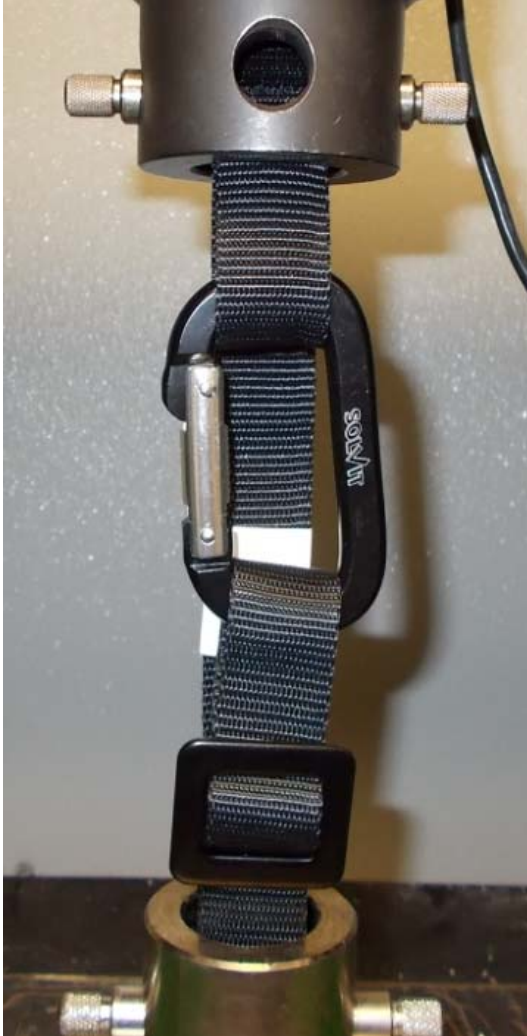
Carabiner with straps with metal buckle
(62408) (#1)

Set up

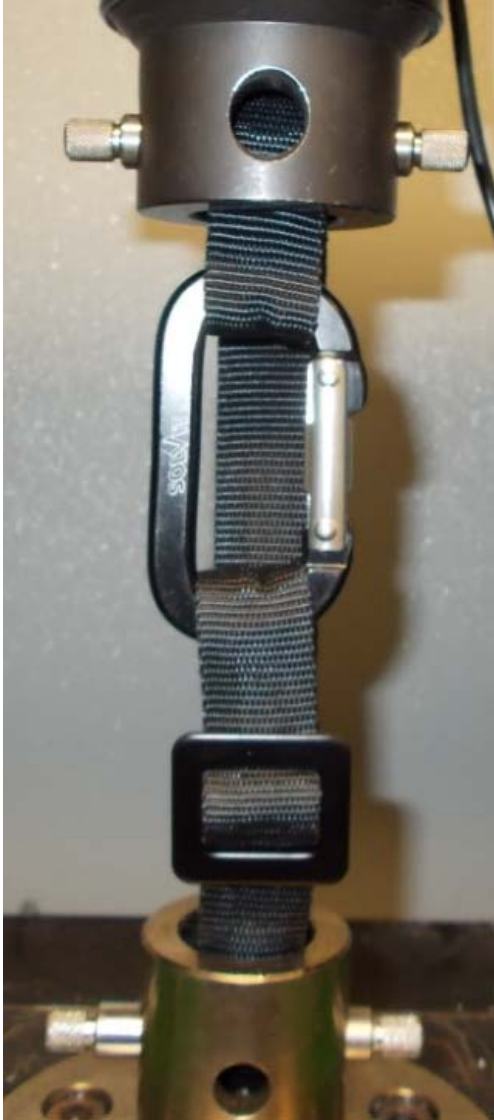
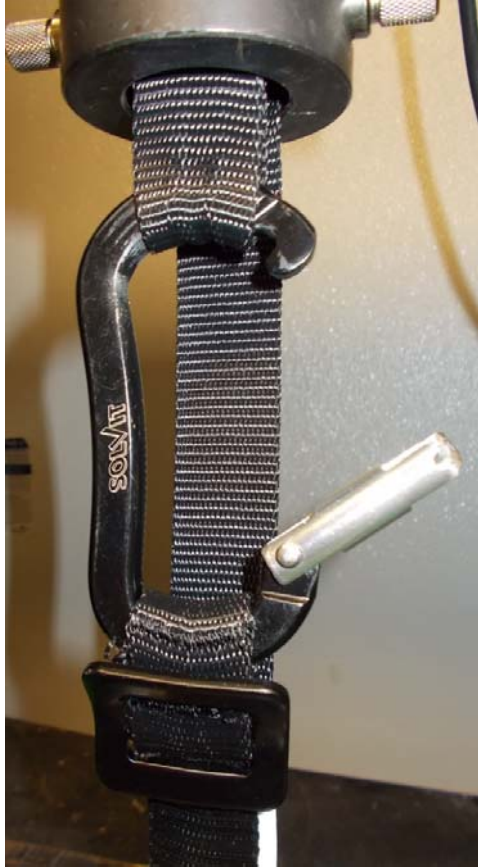
<u>Carabiner with straps with metal buckle</u> <u>(62408) (#2)</u>	
-------------------------------------------------------------------------------------	--

Set up	Final failure; carabiner (pin/hook area breakage/deformation) and buckle deformation
--------	--------------------------------------------------------------------------------------

Noted @ 3,940 lbs.
--	---------------------------
